THE DAMAGE TO STRUCTURES CAUSED BY THE SECOND MIYAKOJIMA TYPHOON

ISHIZAKI, Hatsuo ...[et al]. THE DAMAGE TO STRUCTURES CAUSED BY THE SECOND
MIYAKOJIMA TYPHOON. Bulletin of the Disaster Prevention Research Institute 1968, 18(1):
1-14

by Hatsuo ISHIZAKI, Junji KATSURA and Tatsuo MUROTA

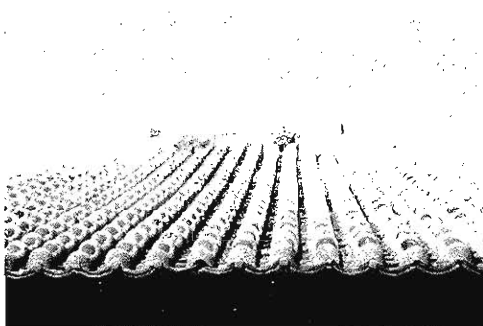
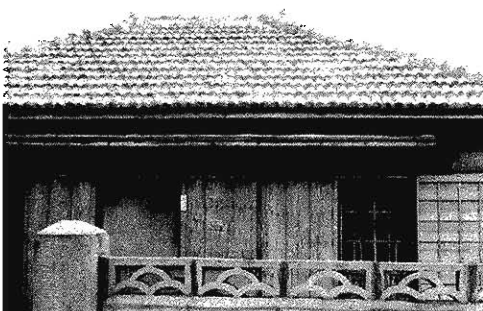
Most of the buildings in Okinawa are wooden hip-roofed ones with tile roofings, which are divided into two types; clay tile roofings and cement tile roofings. (Photo. 1, Fig. 1)

Photo. 1 Two types of roofings of wooden buildings in Okinawa :
(a) clay-tile roofing, (b) cement-tile roofing.
